vebrocrete Industrial (Gloss / Satin)

Medium duty PU concrete with UV resistant, gloss or satin sealer for industrial applications.

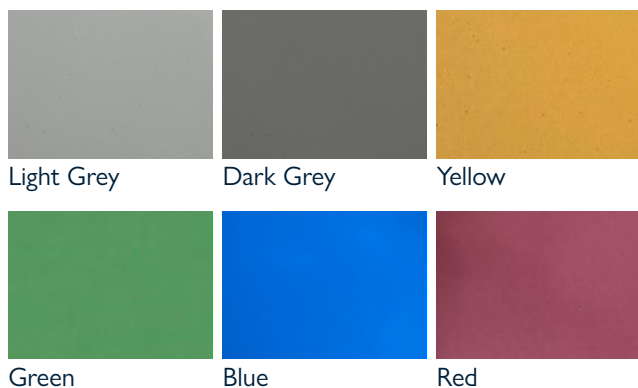
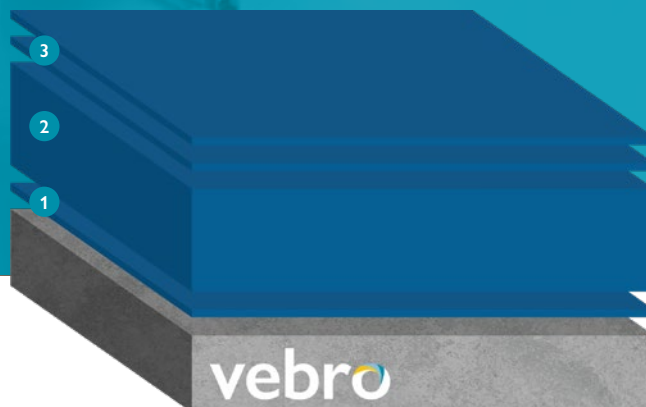
system design & typical properties

1 Primer	vebrocrete PU MF (pf) (unpigmented)	1.90 kg/m ²
2 Body Coat	vebrocrete PU MF (pf)	5.70 kg/m ²
3 Coating	vebro PU UV Seal (Gloss) or vebro PU UV Seal (Satin)	1st coat: 0.12 kg/m ² 2nd coat: 0.12 kg/m ²
